Re: Gym Parapet Wall Movement  
Linderman School  
Polson, MT.

Project **LINDERMAN SCHOOL - POLSON**

Subject **GYM WALL STABILIZATION**

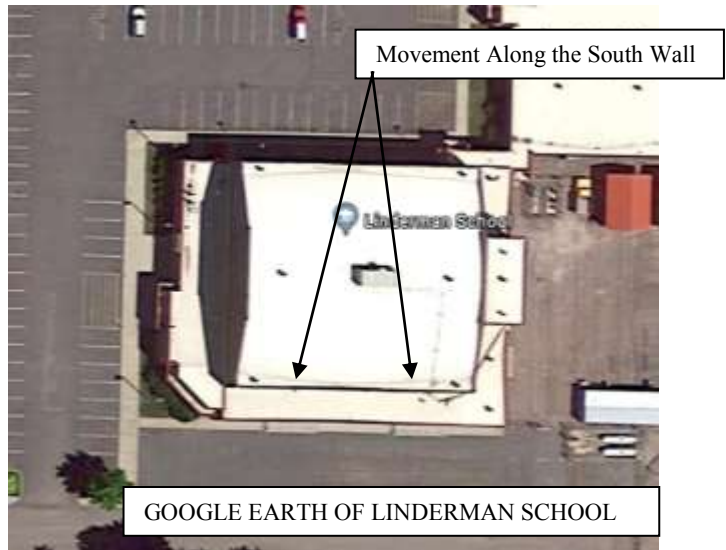
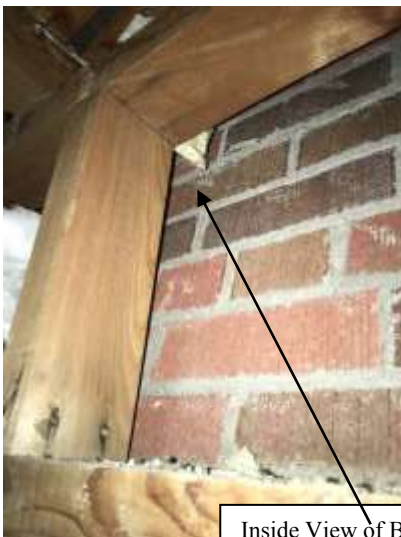
Carl:  
At your request, we have investigated the parapet wall movement at the Linderman School at Polson. The south parapet wall has move outward (to the south) causing a noticeable bow in the wall. This movement and bow is considered to be very recent. I was at the school on late Tuesday afternoon. January 2<sup>nd</sup>.

The gym wall is a triple wythe, unreinforced brick masonry (URM) wall to the level of the arched bowstring roof trusses and corresponding arched roof structure. Above the arched roof, the wall shifts to a double wythe wall. For a significant portion of the south wall, the double wythed, upper portion has shifted outward. Please see attached rough sketch A for reference to this condition. The cause is considered to be seasonal, cyclic drifting snow and ice against the wall. Further explanations have been generated by your office in earlier reports. This letter and sketches address a stabilization repair.

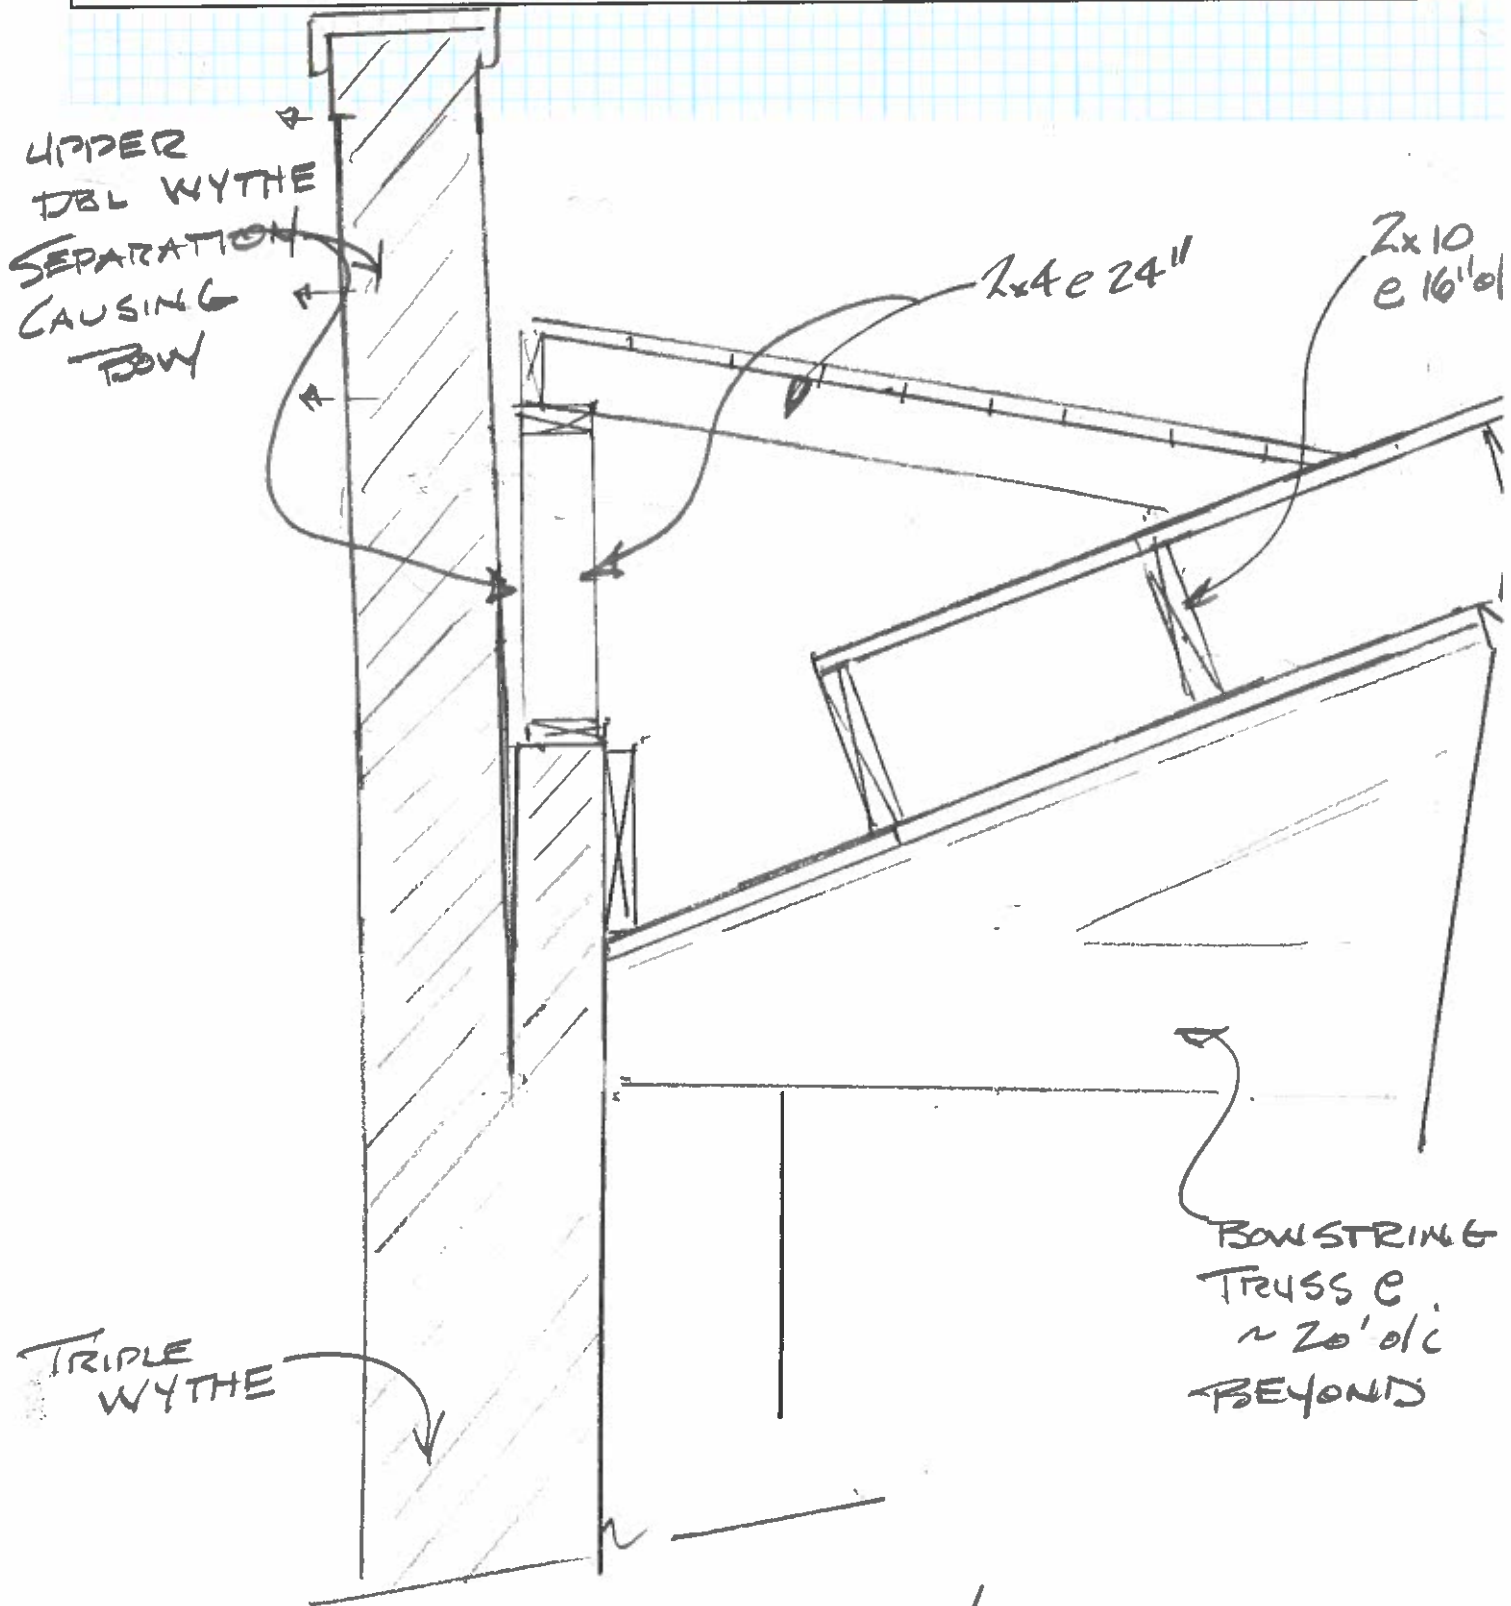
(A)

EXISTING SECTION
