FIELD REPORT

05

PROJECT: Polson Linderman Gym Partial Collapse
LOCATION: 4th Street East & 5th Avenue Polson MT
REPORT DATE: 01-29-18

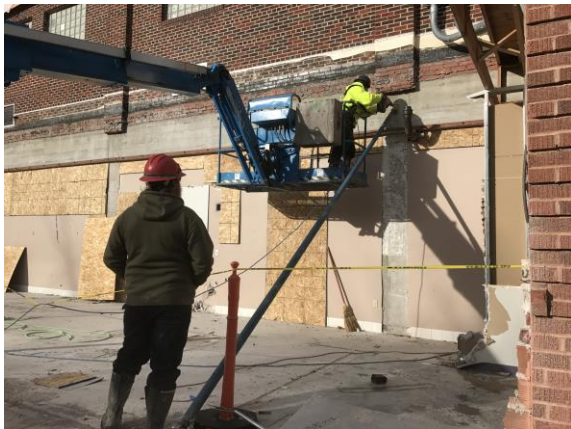
Swank installing bracing

7. Two Swank workers were installing diagonal shoring at the demolished locker room.

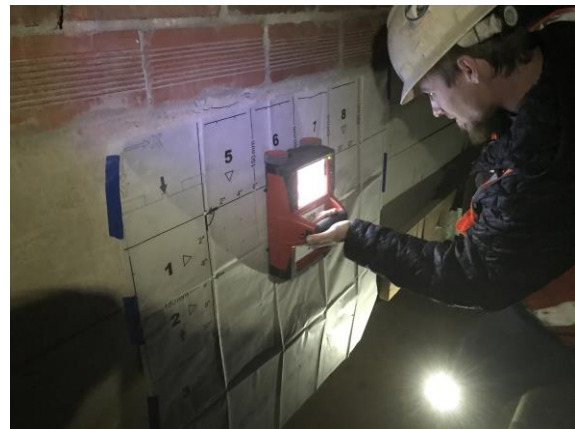
A-core scanning bond beam with GPR unit

1. Levi Hubble of A-Core used a hand held ground penetrating radar unit to view the internal structure of the concrete columns and beams of the south side of the Linderman Gymnasium.

4. There are no horizontal bars or vertical ties in the concrete beams. Levi scanned several beams to make sure, and scanned both the inside and outside faces for further redundancy.

5. Wires about 0.04" in dia. can be seen at regular spacings in the beams, which we surmised were used to help hold the board forms from spreading while the concrete was poured.

6. Levi also discovered a large area of rock pocketing inside the beam between columns 1 and 2. Dan G. noted several areas of parging which appeared to be at rock pockets on the beam surface.

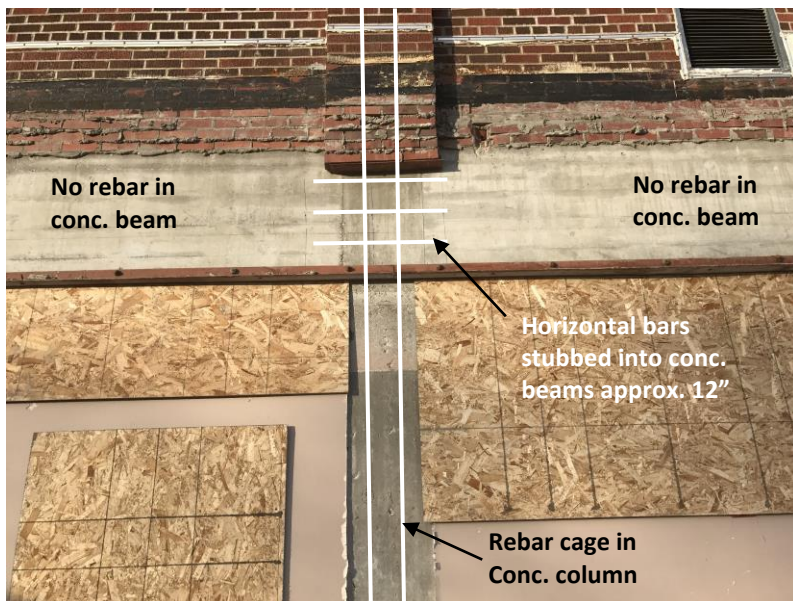
Schematic rebar diagram

2. The concrete columns have a re-bar cage consisting of vertical bars with horizontal ties as would be expected.
3. There are several horizontal bars connecting the vertical column cages to the concrete beams on either side of the column. However, these bars extend only about 12" into the beams.
