FIELD REPORT

PROJECT: Polson Linderman Gym Partial Collapse
LOCATION: 4th Street East and 5th Avenue Polson MT
DATE OF REPORT: 01-23-18

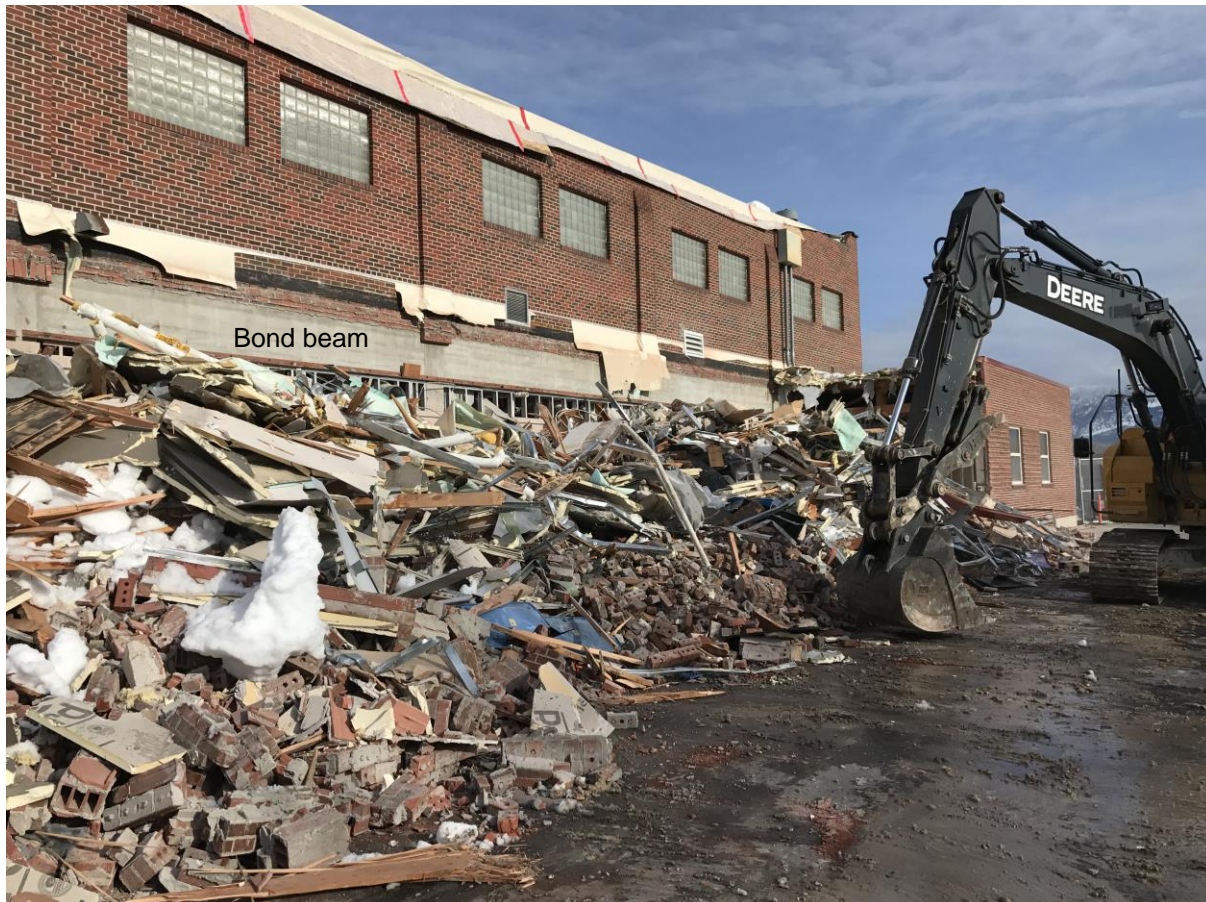
Locker rooms demolished

1. Swank crew worked with Dan Giles to prepare the locker room area for demolition.
2. At 10:30 AM Siderius Excavation began demolition of the south masonry wall and continued through the locker room area until the initial demolition was complete at around 1:30 PM. Swank assisted using a man lift and two workers.

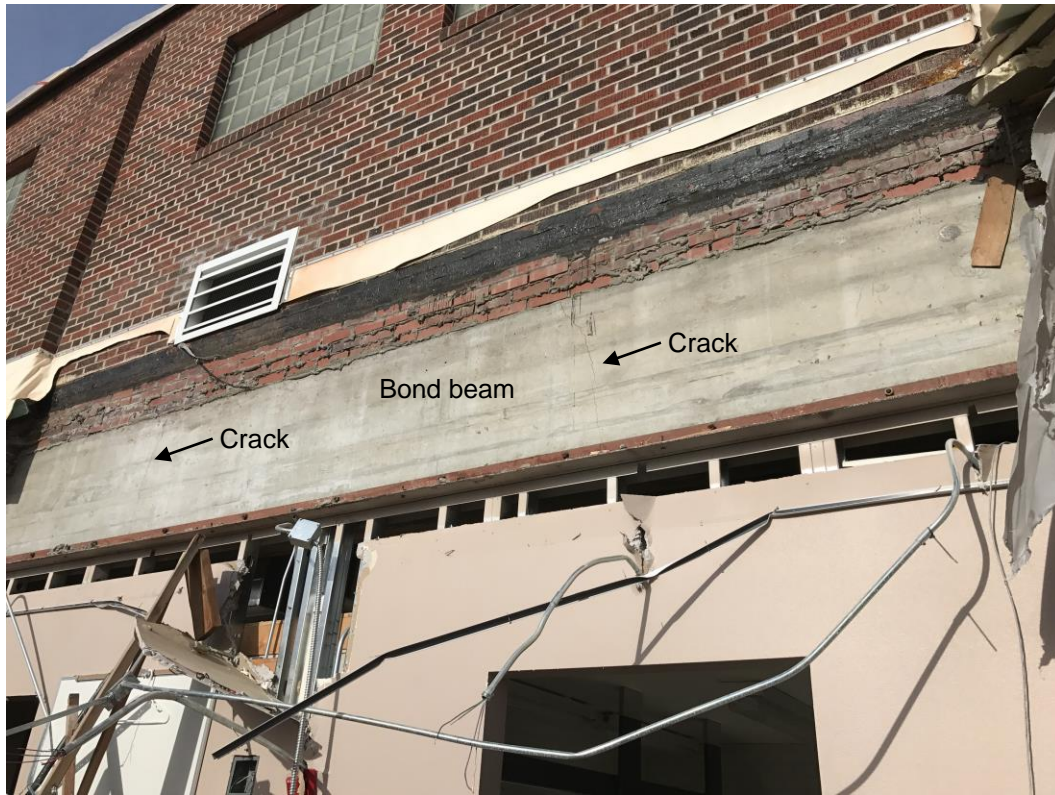
Bond beam

7. A 32" deep concrete bond beam supports the upper gymnasium masonry exterior wall. The bond beam shows 1 to 2 significant cracks in each span between columns, along with other smaller cracks. It is not known when these cracks occurred. The cracks do not extend up into the masonry wall above.

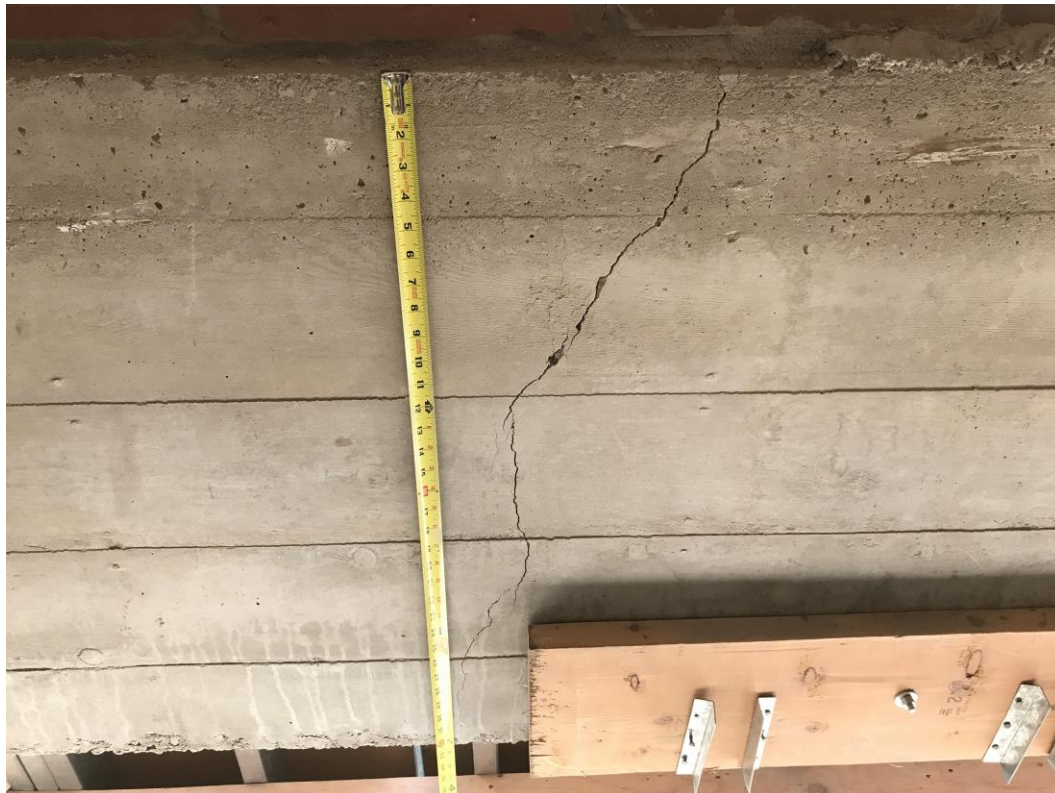
View of cracked bond beam
(photo taken inside mechanical attic under mezzanine seating)

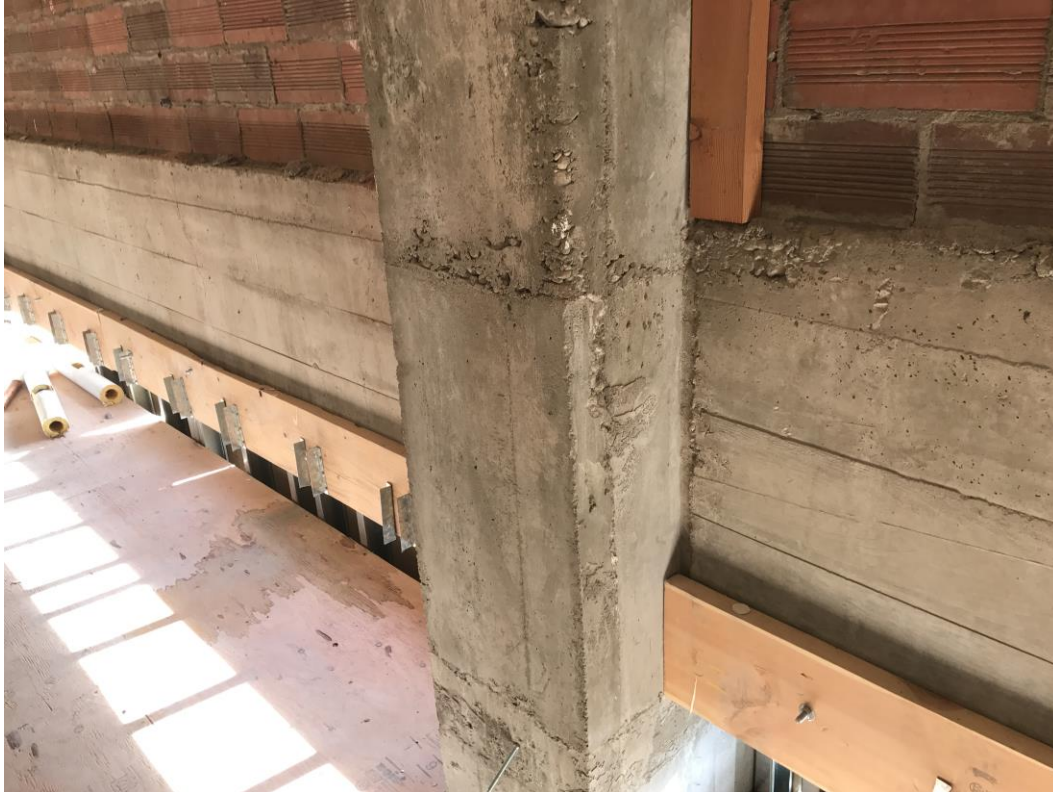
Cold joints in concrete columns
(photo taken inside mechanical attic under mezzanine seating)

8. No cracks were seen in the concrete columns. Cold joints from the original construction were seen in the columns but appeared to be tight and undamaged.
