January 11, 2018

Re: Gym Parapet Wall Collapse
Linderman School
Polson, MT.

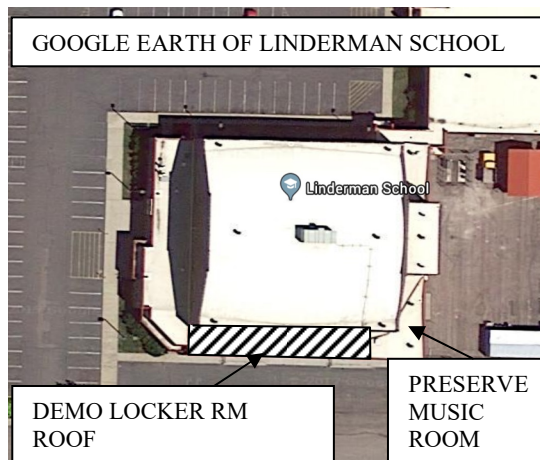
This is an addendum to the letter written on January 8th regarding the collapse of the gym parapet wall and locker room roof of the above noted building. DCI recommends demoing the locker room roof from the west end to the music building located on the east end. No demo is required for the music room. The south brick locker room wall may also be demoed along this same area (no demo beyond the music room). Temporary sheathing should be placed on the music room interior wall (spanning N/S) where roof and wall demo terminate to enclose it from the outside.
